## Inspection Report

Palmyra VA 22963

**Jensen Home Inspections LLC.**

<b>Date:</b> 4/25/2018	<b>Time:</b> 01:00 PM	<b>Report ID:</b> 4/25/18
<b>Property:</b> [REDACTED] Palmyra VA 22963	<b>Customer:</b> [REDACTED]	<b>Real Estate Professional:</b> Amanda Spigone Keller Williams Realty

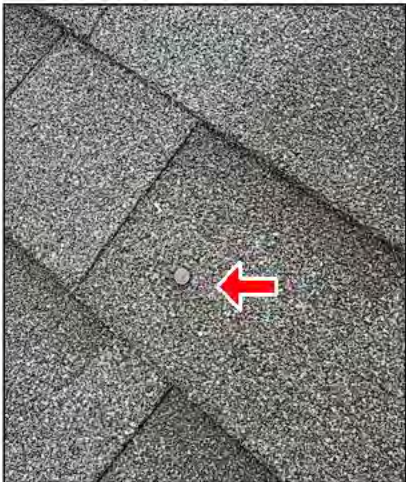
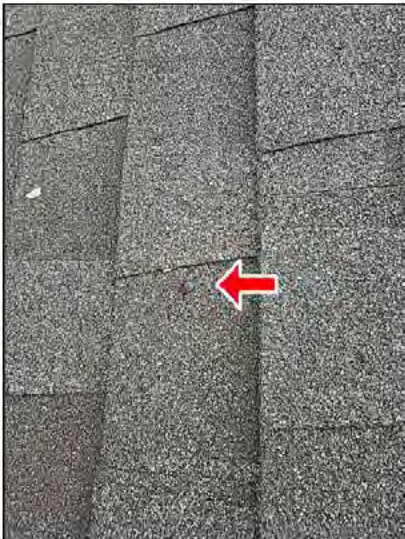
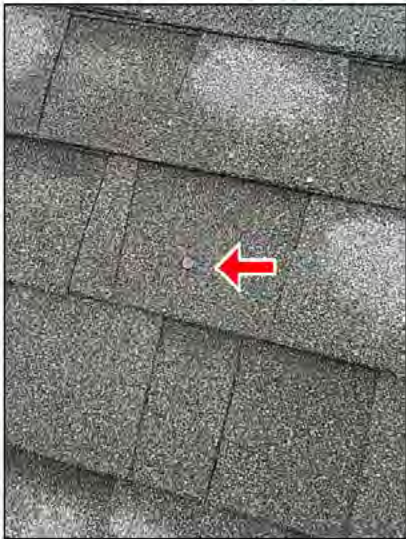
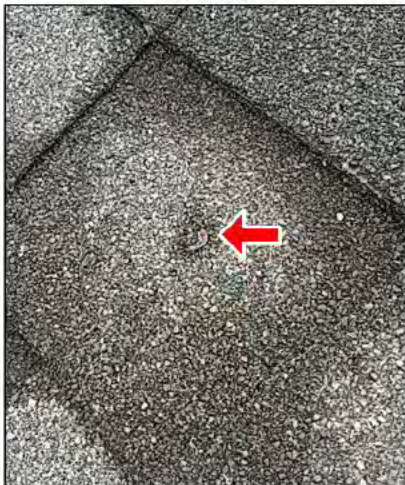
1.0 There are numerous nail-pops coming through the roof system. I recommend having all these areas further evaluated and caulked by a qualified roofer to prevent any leaks from entering the home.

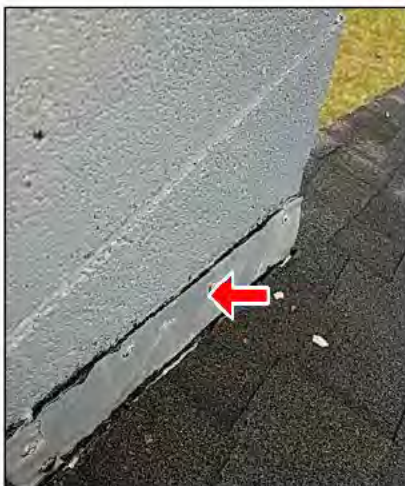
1.1 Item 1(Picture)

1.1 The caulk around the top of the flashing of the chimney is failing, I recommend having this re-caulked.

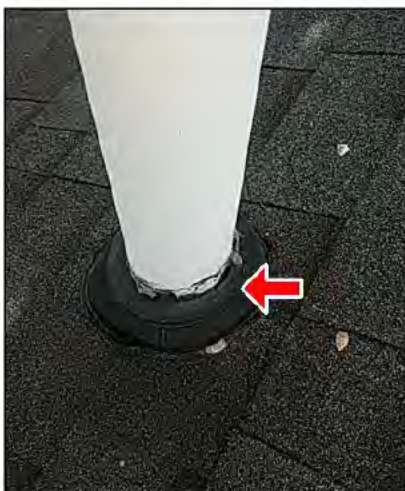
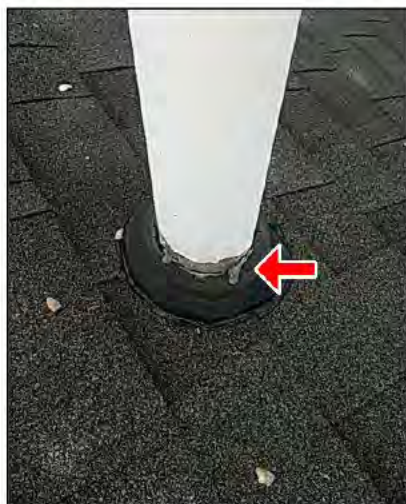
1.2 (1) The rubber boots around the plumbing vent stack on the backside of the home have failed. which can allow water to enter the attic space. I recommend having this repaired by a qualified roofer.

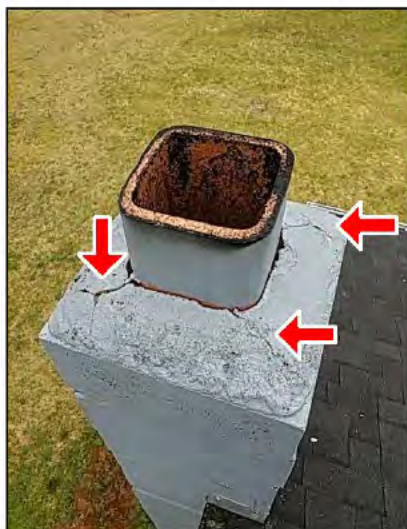
1.2 Item 3(Picture) Crown cracks.

(2) The chimney has several issues, the top course of block is not properly secured and moves, the crown on top of the chimney has cracks that should be repaired, and I recommend having a chimney cap installed on the flue liner. I also recommend having a qualified mason make these repairs per their recommendation.

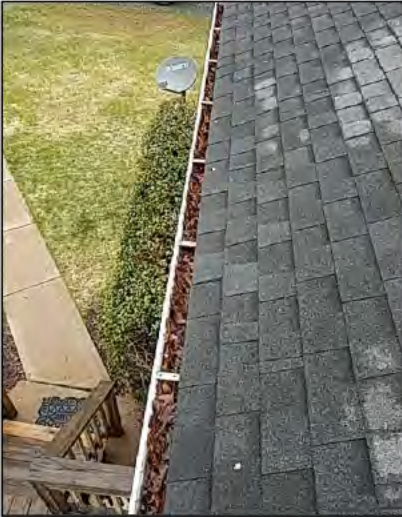
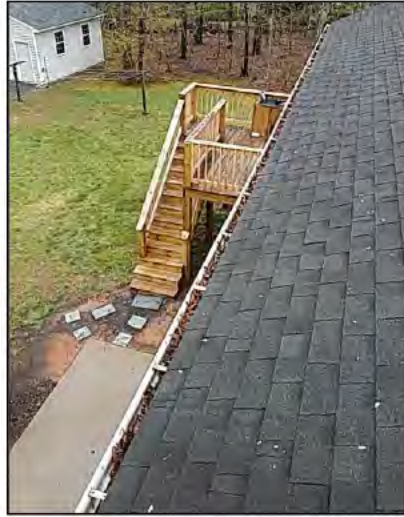
1.3 (1) I recommend having all the gutters cleaned to ensure the system is working correctly.

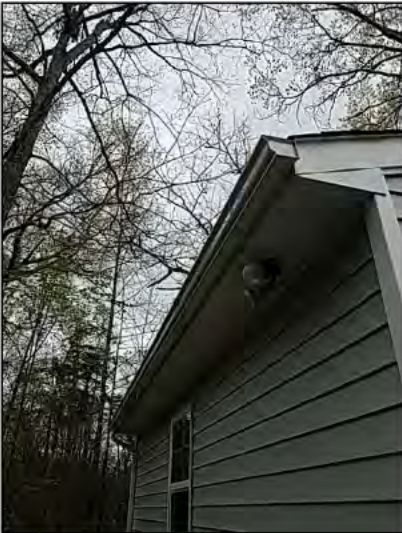
1.3 Item 3(Picture)

(2) I recommend having the gutters on the garage cleaned to ensure the system works properly.

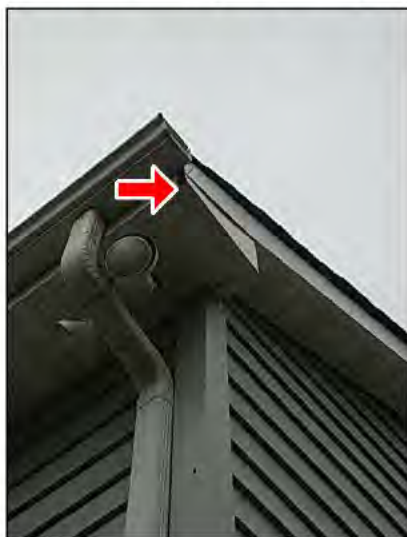
2.0 Item 1(Picture)

2.0 (1) The aluminum flashing wrap at the end of the soffit and fascia on the back right of the home is pulling away, I recommend having his properly secured.

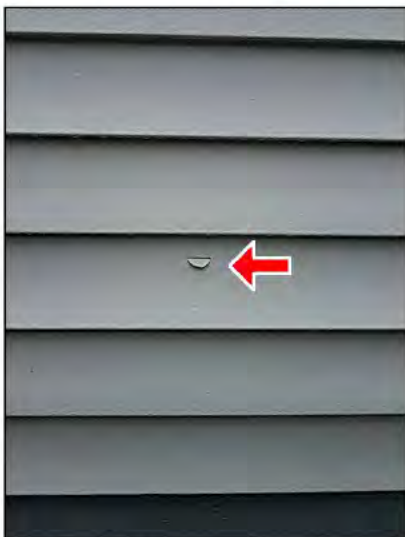
2.0 Item 2(Picture)

(2) There is a damaged piece of vinyl siding on the left side of the home, I recommend having this replaced.

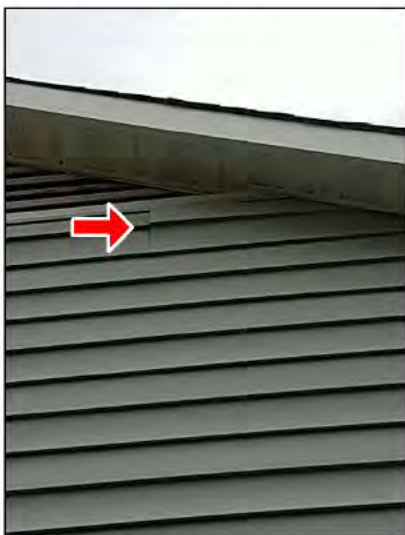
2.0 Item 3(Picture)

(3) There is a section of vinyl siding on the left side of the home just below the gable vent that is popped out, I recommend having this re-installed.

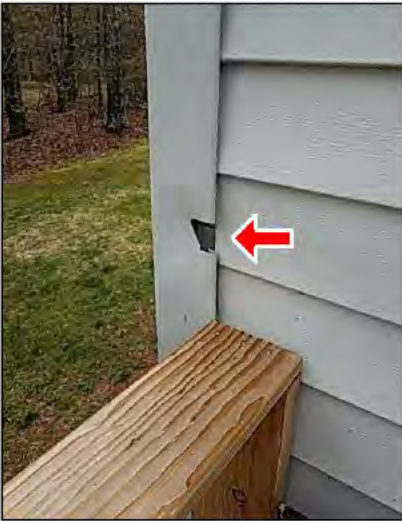
2.0 Item 4(Picture)

(4) There is damage to the vinyl corner trim on the back left of the home, I recommend having it replaced.

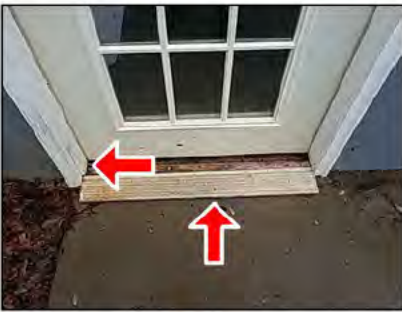
2.1 Item 1(Picture)

2.1 The threshold for the basement door is not properly installed, is loose, and there is also signs of rot starting on the base of the left door jamb. I recommend having a qualified person makes these repairs per their recommendation.

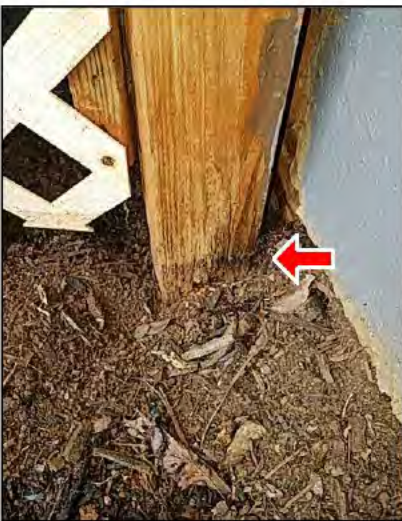
2.3 Item 1(Picture)

2.3 The back right corner post of the front deck system has rot and decay at the base. I recommend having this further evaluated by a licensed contractor and repairs made per their recommendation.

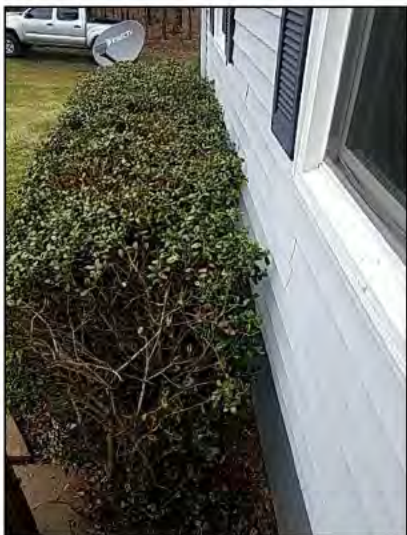
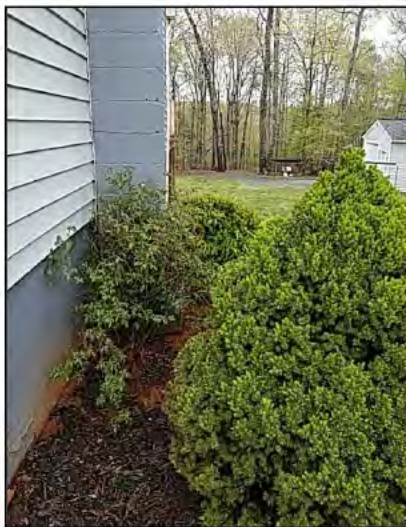
2.4 (1) I recommend keeping any and all vegetation around the home cut back at least 12 in to prevent any physical damage to the siding and the home.

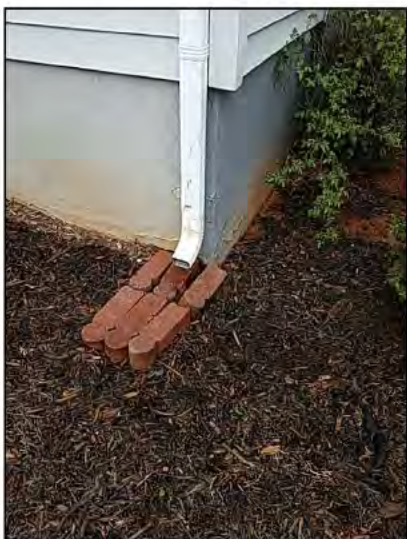
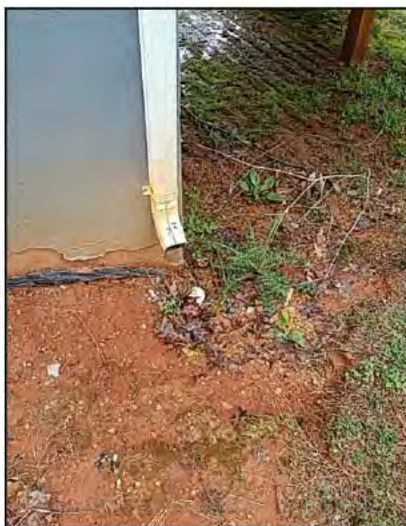
(2) I recommend adding extensions to all downspouts to divert water further away from the foundation walls.

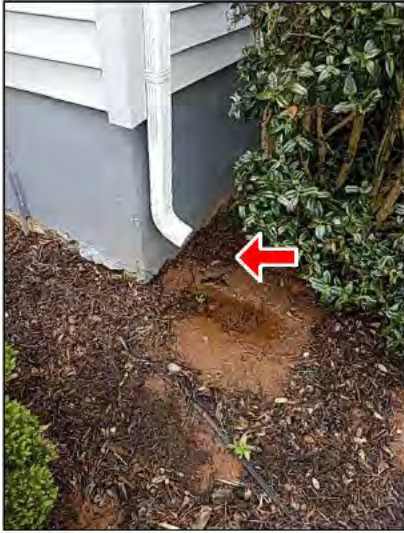
2.4 Item 5(Picture)

(3) The front left downspout is draining too close to the home and water is pooling up at the corner of the home. This could be the cause of the water entering the basement through the foundation wall. I recommend having an extension added to the downspouts to divert water away from the foundation wall.

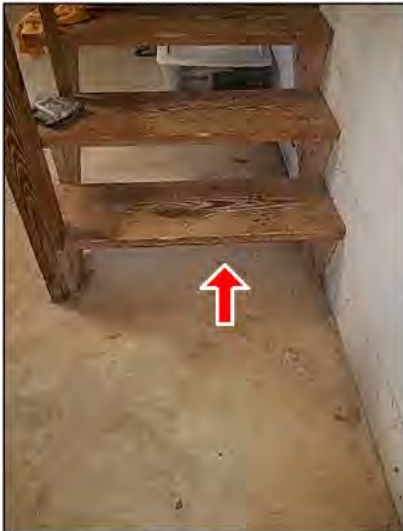
4.3 Item 1(Picture)

4.3 The bottom step on the stairs in the basement is too high which this is a trip hazard, I recommend having this repaired.

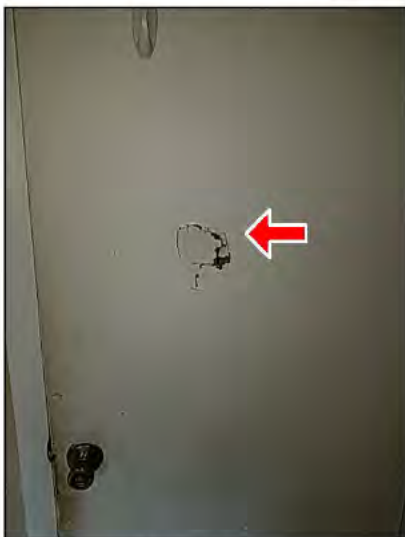
4.5 Item 1(Picture)

4.5 (1) The door to the first bedroom on the left is damaged, I recommend having this replaced.

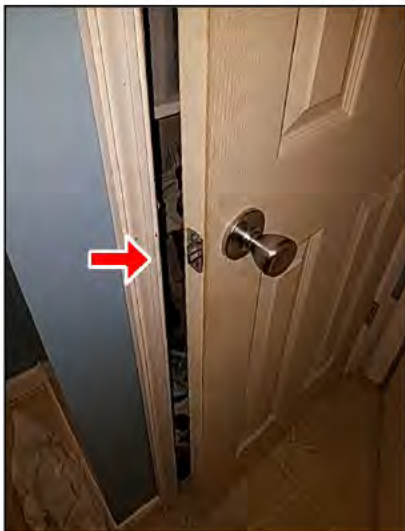
4.5 Item 2(Picture)

(2) The closet door in the bathroom does not properly latch, I recommend having the door adjusted so it closes properly.

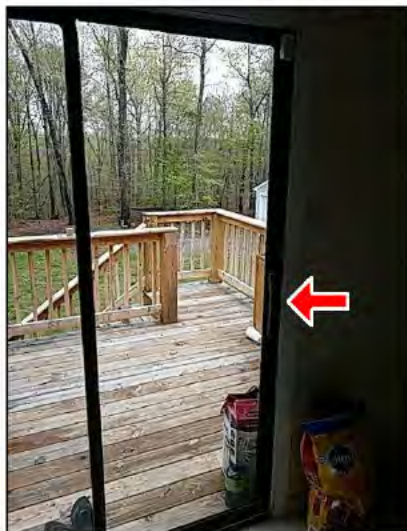
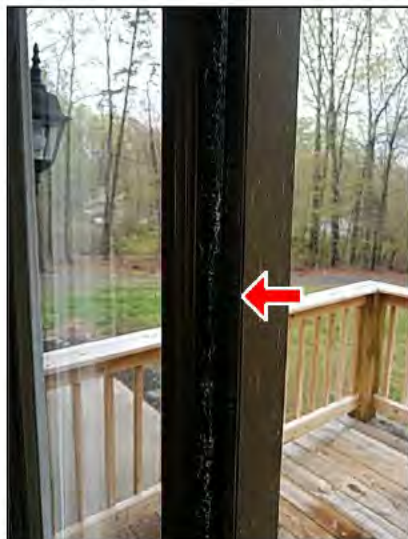
(3) The inner pane of glass for the sliding glass door to the back is broken, and the frame where the door locks are also loose. I recommend having the door replaced.

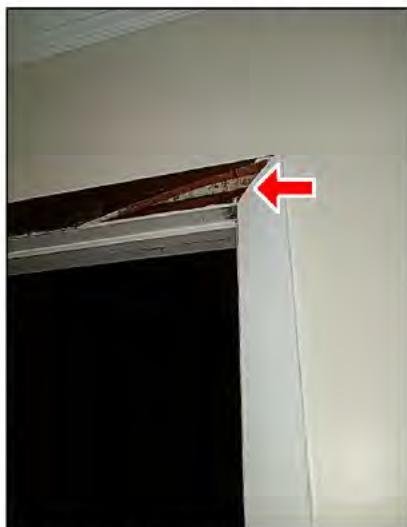
4.5 Item 5(Picture)

(4) There is a damaged piece of trim on the door leading to the basement, I recommend having this replaced.

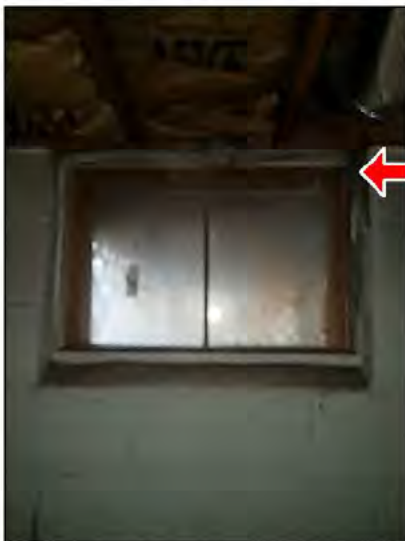
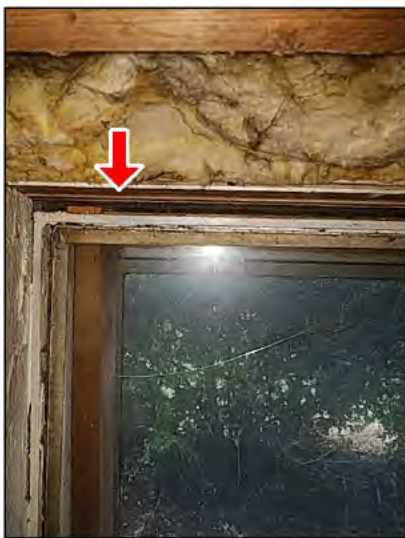
4.6 Two of the basement windows have daylight visible around them which could allow unwanted pets to enter the home. I recommend having these properly sealed by a qualified person.

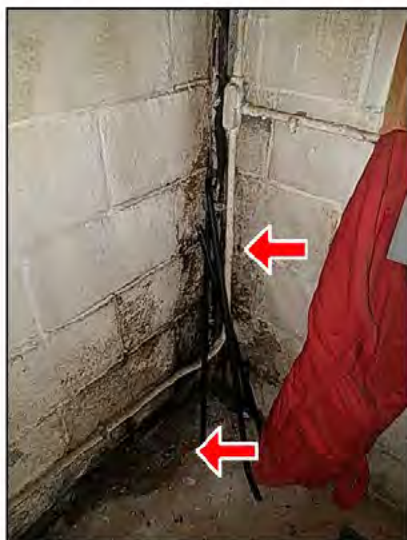
5.0 Item 1(Picture)

5.0 The front left corner of the foundation wall in the basement has signs of moisture on the block and the floor. I recommend having a licensed contractor further evaluate and correct the drainage issue on the front left of the home to prevent water from penetrating the foundation wall.

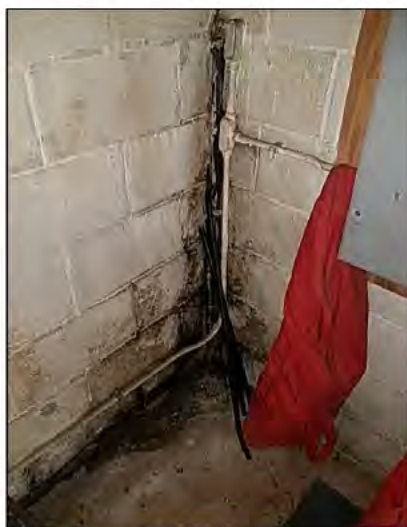
5.1 Item 1(Picture)

5.1 Where the water is coming in the home on the foundation wall in the basement there is fungal growth present, I recommend having a qualified person clean this area.

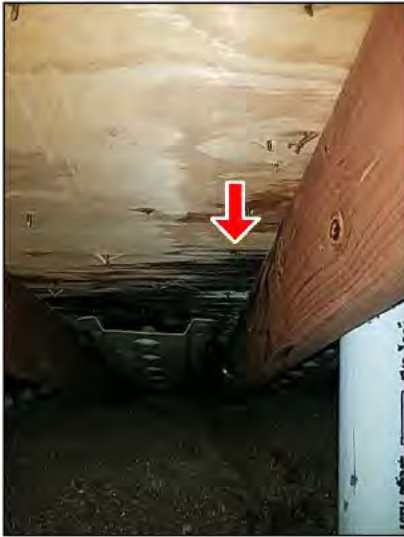
5.5 Item 1(Picture)

5.5 The section of sheathing below the plumbing vent stack in the attic has signs of rot and decay as well as visible fungal growth. I recommend having this further evaluated and repaired or replaced by a qualified person's recommendation.

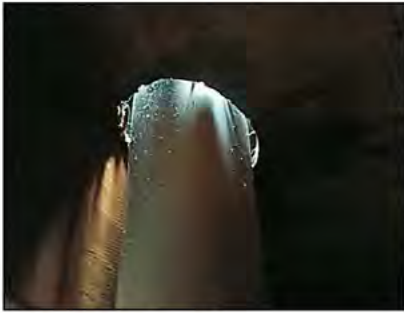
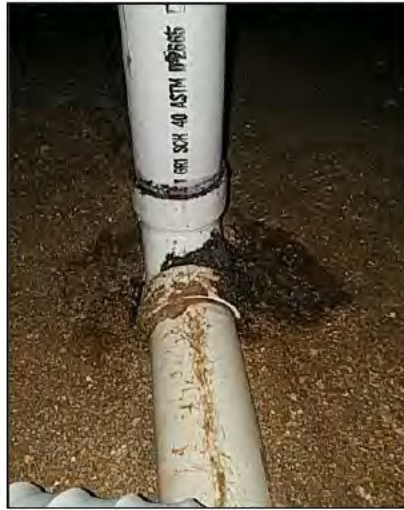
6.0 (1) There is daylight visible around a plumbing vent stack in the attic which is allowing water to enter the attic space. The insulation around the base of the plumbing stack is wet and there is rot starting on some of the sheathing below the vent stack. I recommend having a qualified roofer further evaluate and make repairs per the recommendation.

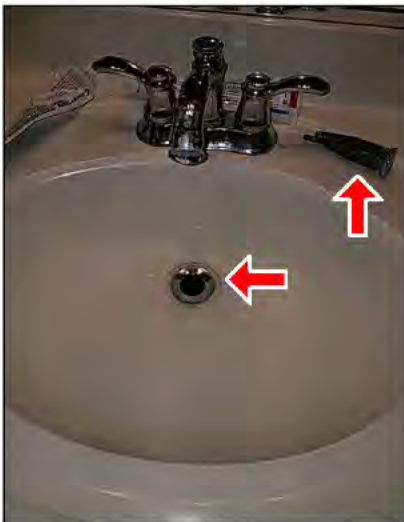
6.0 Item 3(Picture)

(2) The drain stop in the bathroom sink is not connected, I recommend having this installed.

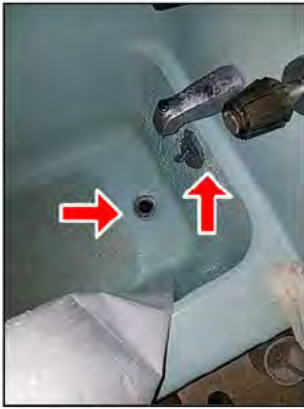
6.0 Item 4(Picture)

(3) The drain stop in the shower/tub is not working properly, I recommend having a qualified plumber make this repair.

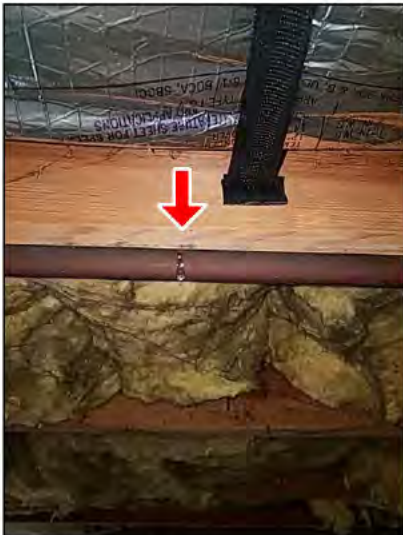
6.1 Item 1(Picture)

6.1 In the basement where the PEX meets the copper water line, there is a slow leak. I recommend having a qualified plumber make this repair.

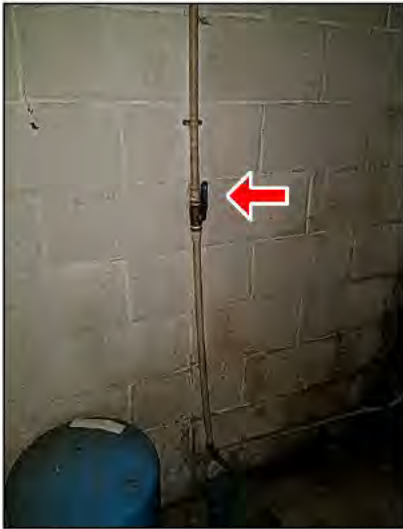
6.3 Item 1(Picture)

6.3 The main water shut-off valve is located in the basement above the pressure tank.

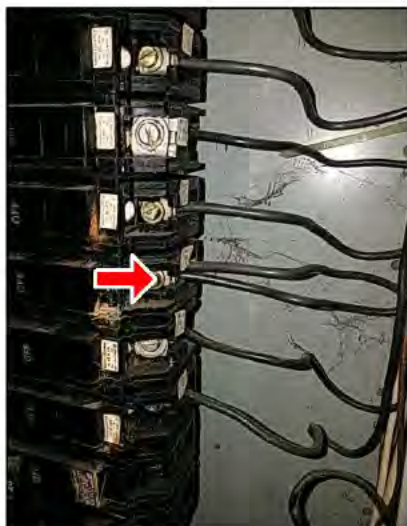
7.2 Item 1(Picture)

7.2 There is a double tap on a 20 amp breaker on the right side in the panel which is a fire hazard. I recommend having a qualified electrician make this repair.

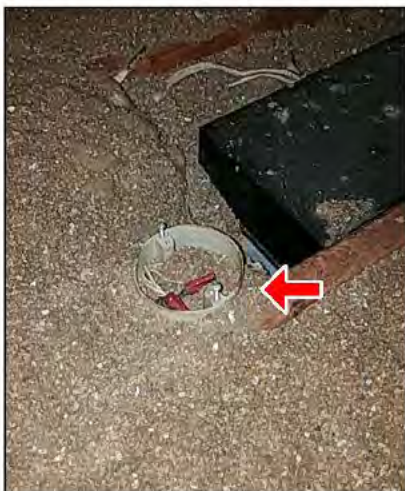
7.3 Item 1(Picture)

7.3 (1) There is an open junction box in the attic space, I recommend having a cover installed.

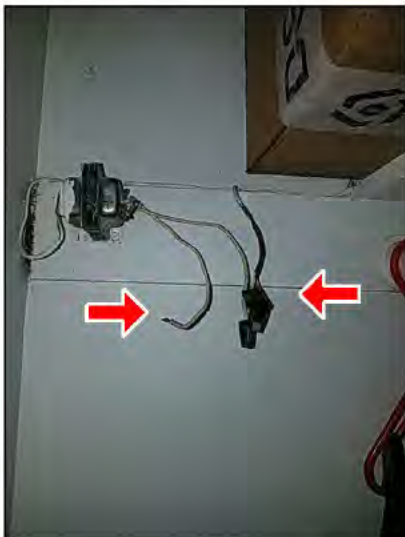
7.3 Item 2(Picture)

(2) There are exposed wires in the closet in the first bedroom on the left. I recommend having an electrician properly run the wires in the junction box.

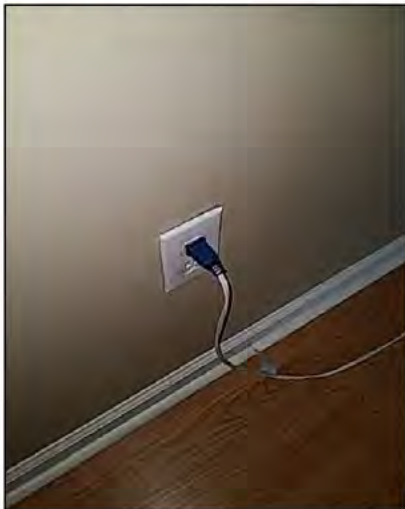
7.3 Item 3(Picture)

(3) There are several receptacles in the home that are loose in the walls. I recommend having a qualified electrician properly secure any loose receptacles.

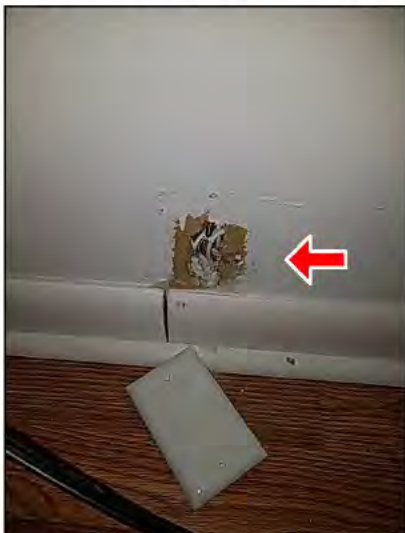
7.3 Item 4(Picture)

(4) In the first bedroom on the right, there is a blank plate mounted to the wall. As I walked by it the cover fell off the wall, and there is a hole with exposed wires tucked into the wall. I recommend having these wires properly run through a junction box and a cover properly installed by a qualified electrician.

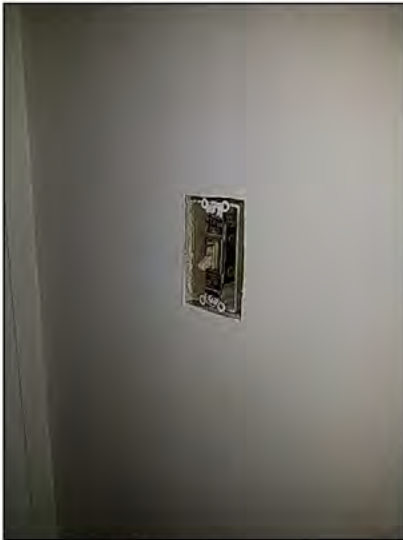
7.3 Item 5(Picture)

(5) The light switch cover in the first bedroom on the right is missing, I recommend having one installed.

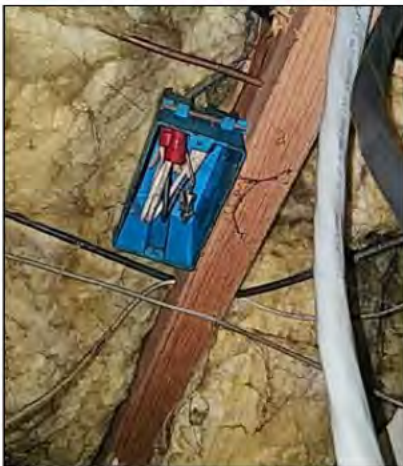
7.3 Item 6(Picture)

(6) There is an open junction box that needs a cover just above the electrical panel in the basement.

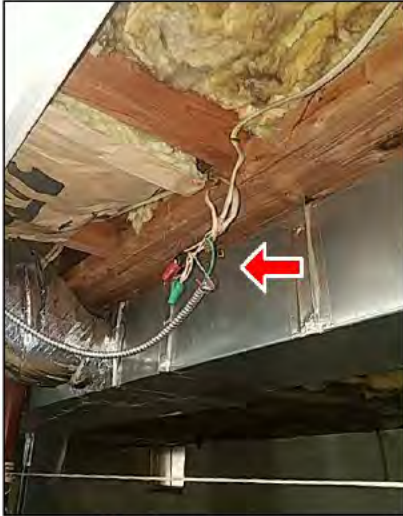
7.3 Item 7(Picture)

(7) The wiring on one of the overhead lights in the basement is exposed. These wires should be run in a junction box, I recommend having a qualified electrician make these repairs.

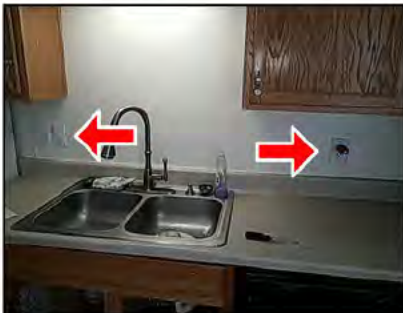
7.5 Item 1(Picture)

7.5 The receptacles in the kitchen that are all within 6 feet of the sink are not connected to a GFCI receptacle or GFCI breaker. I recommend having a qualified electrician make this repair.

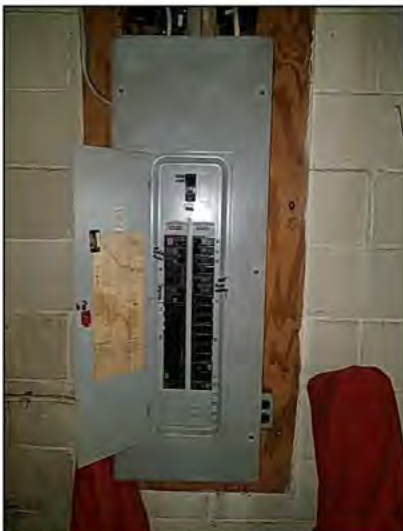
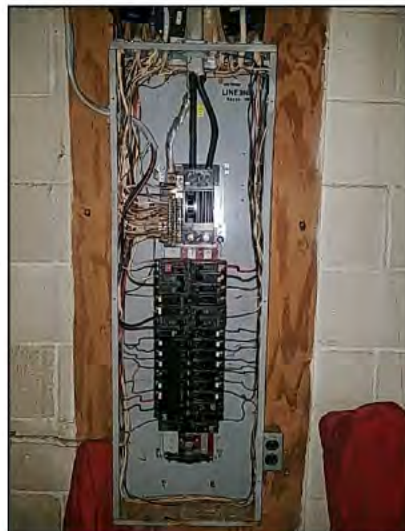
7.6 (1) The main distribution panel is located in the basement.

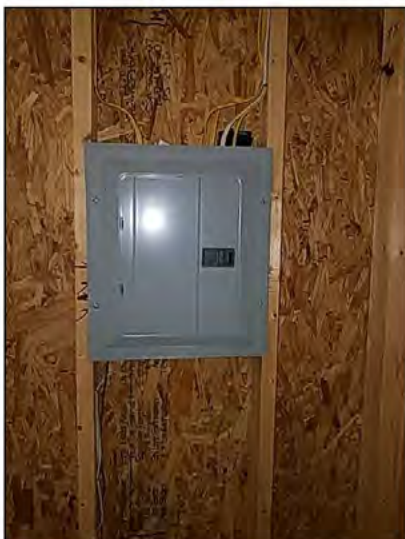
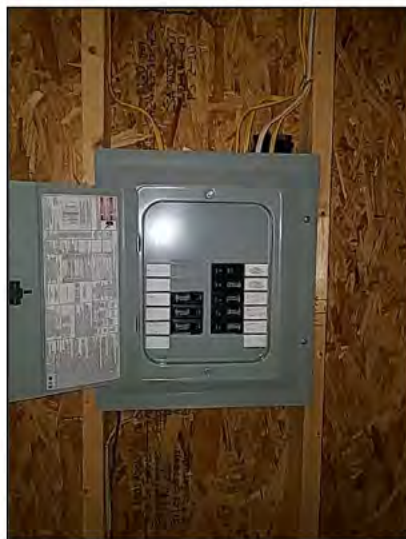
(2) There is a sub panel located in the garage.

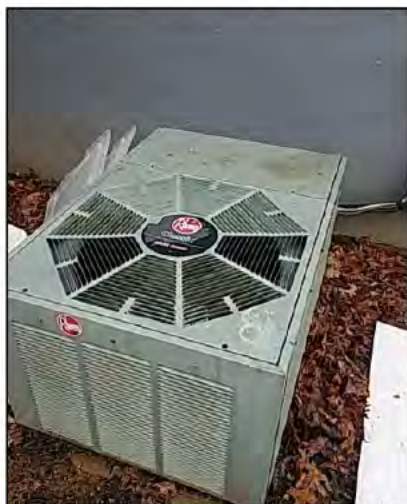
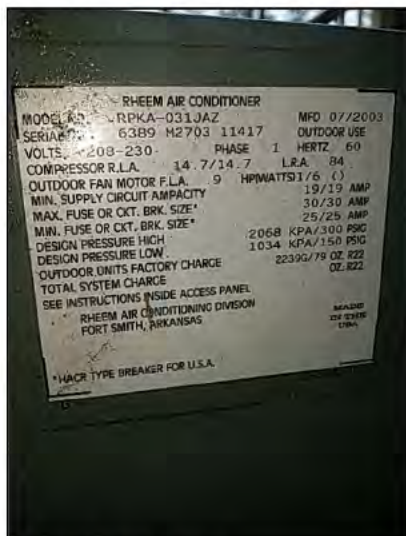
8.0 The heat pump is a Rheem, manufactured in 2003, and is a two and a half ton unit. The system is near or at the end of its useful manufactured life, and runs on R22 freon which is being phased out and costly to repair if needed. I recommend having a licensed HVAC technician clean, service, and further evaluate the system.

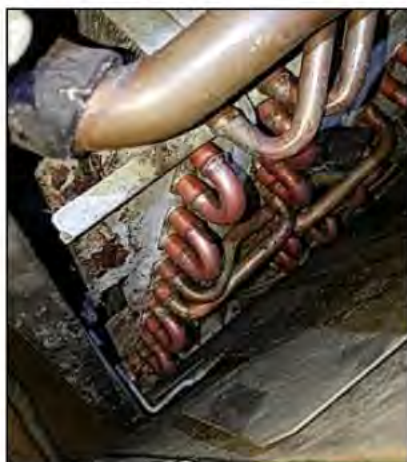
8.3 Item 1(Picture)

8.3 They are early signs of rust around the coil in the air handler as well as some microbial growth. I recommend having a licensed HVAC technician clean, service, and further evaluate the unit.

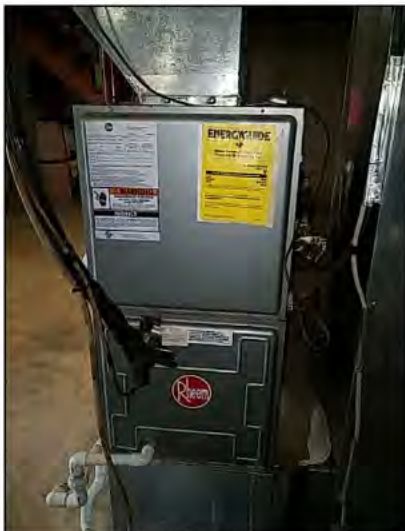
8.8 Item 1(Picture)

8.8 The air handler is a Rheem, manufactured in 2003, and is a two and a half ton unit.

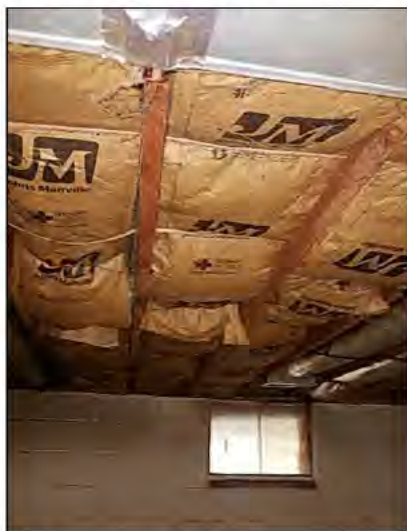
9.1 Item 1(Picture)

9.1 Most of the flooring insulation in the basement is installed upside down, and the paper vapor barrier is supposed to be against the flooring. I recommend having this corrected or the insulation replaced.

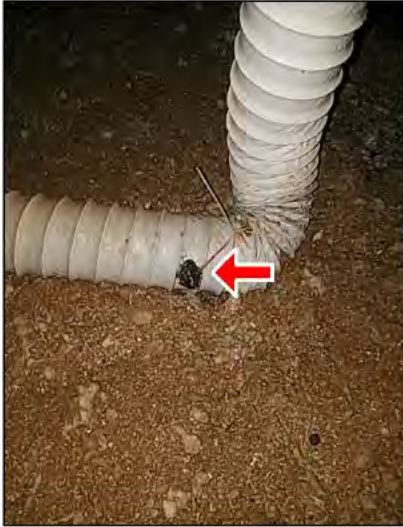
9.4 Item 1(Picture)

9.4 In the attic space, the bathroom vent has a mouse hole in the side and it does not vent to the exterior of the home. I recommend having this replaced and properly vented to the exterior of the home.

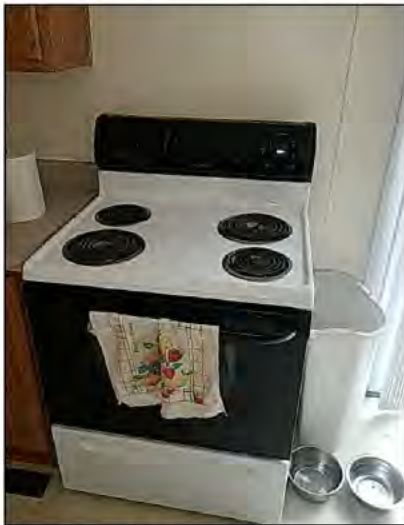
10.1 Item 1(Picture)

10.1 The range is missing its anti-tip plate, I recommend having one installed.

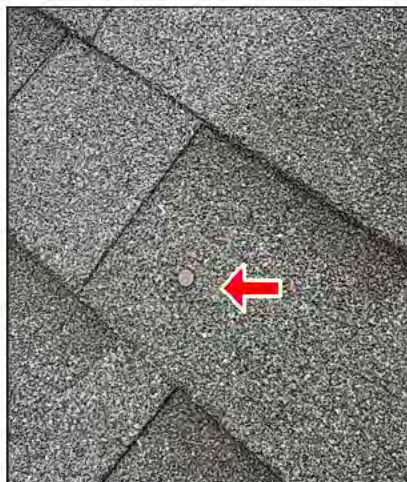
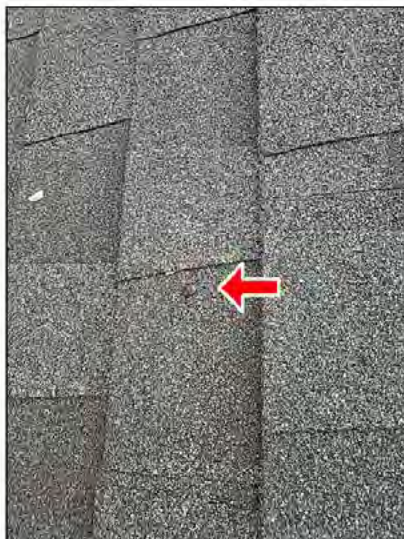
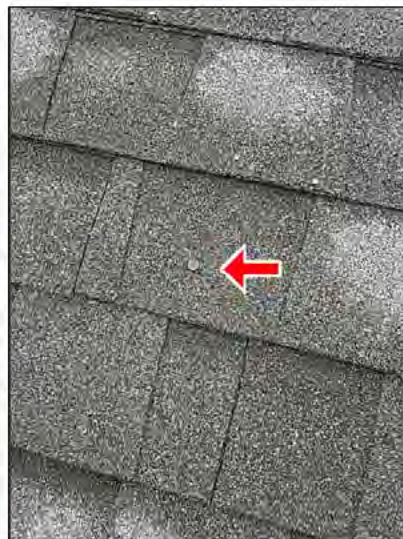
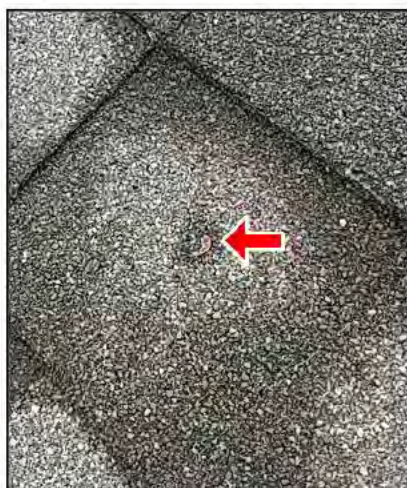
There are numerous nail-pops coming through the roof system. I recommend having all these areas further evaluated and caulked by a qualified roofer to prevent any leaks from entering the home.

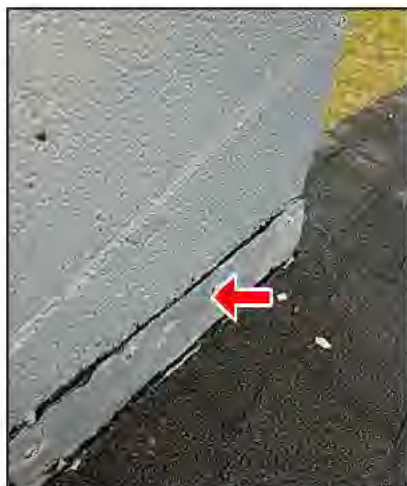
1.1 Item 1(Picture)

The caulk around the top of the flashing of the chimney is failing, I recommend having this re-caulked.

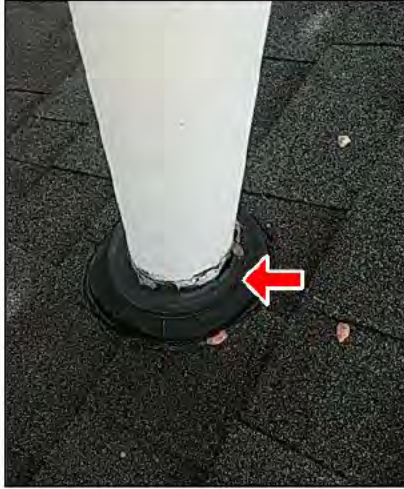
1.2 Item 1(Picture)

(1) The rubber boots around the plumbing vent stack on the backside of the home have failed. which can allow water to enter the attic space. I recommend having this repaired by a qualified roofer.

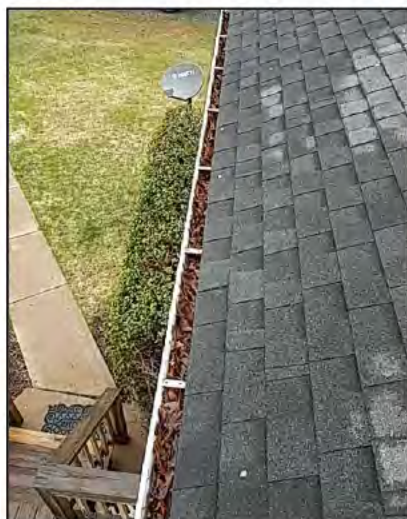
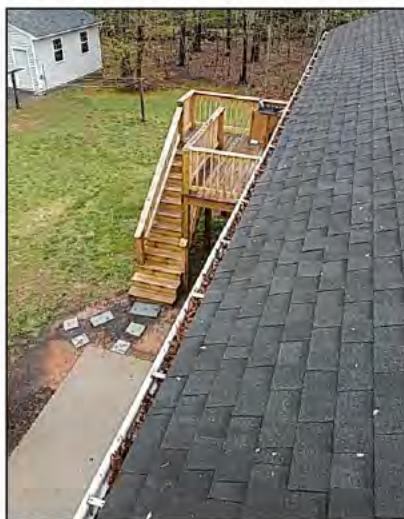
(1) I recommend having all the gutters cleaned to ensure the system is working correctly.

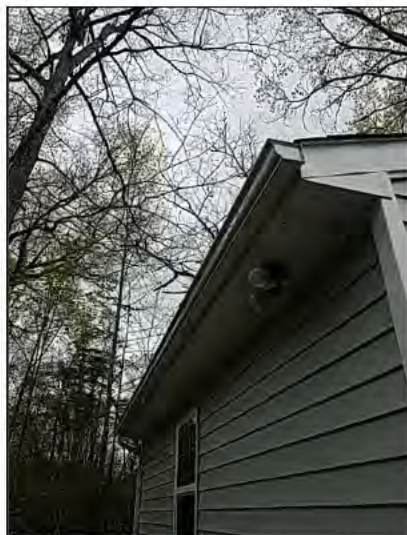
1.3 Item 3(Picture)

(2) I recommend having the gutters on the garage cleaned to ensure the system works properly.

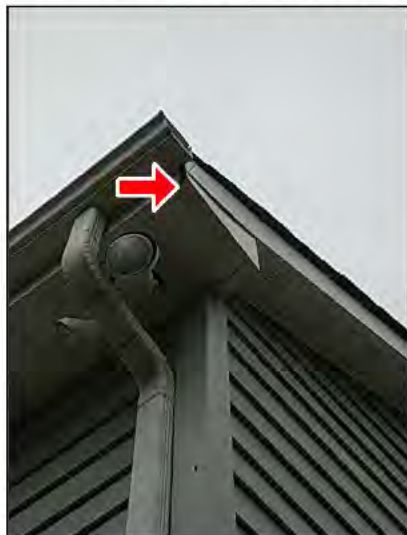
2.0 Item 1(Picture)

(1) The aluminum flashing wrap at the end of the soffit and fascia on the back right of the home is pulling away, I recommend having this properly secured.

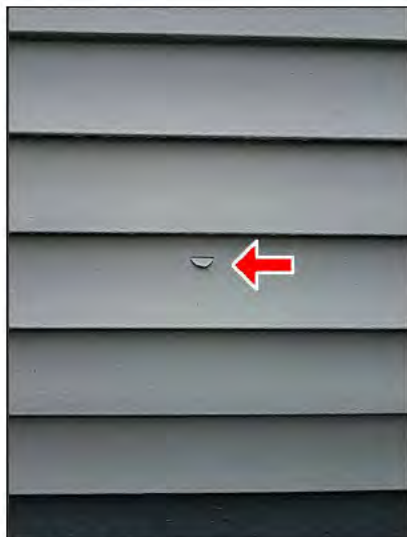
2.0 Item 2(Picture)

(2) There is a damaged piece of vinyl siding on the left side of the home, I recommend having this replaced.

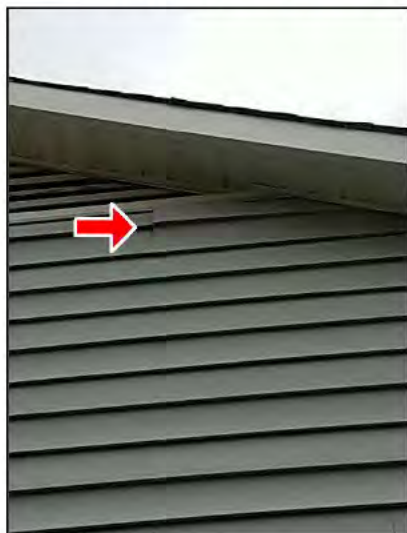
2.0 Item 3(Picture)

(3) There is a section of vinyl siding on the left side of the home just below the gable vent that is popped out, I recommend having this re-installed.

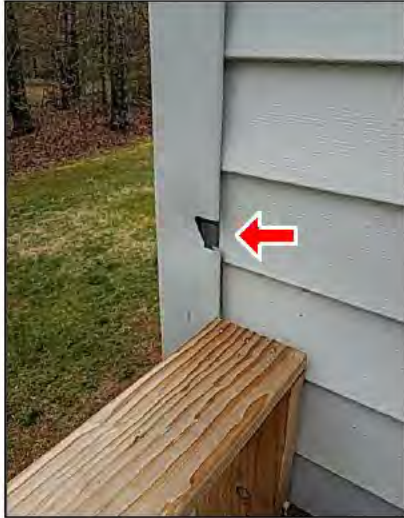
2.0 Item 4(Picture)

(4) There is damage to the vinyl corner trim on the back left of the home, I recommend having it replaced.

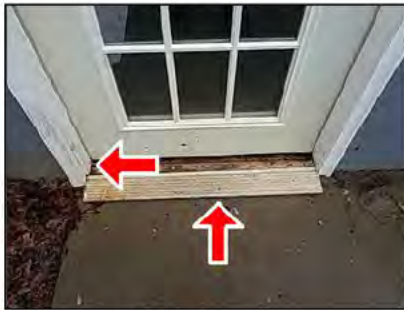
2.1 Item 1(Picture)

The threshold for the basement door is not properly installed, is loose, and there is also signs of rot starting on the base of the left door jamb. I recommend having a qualified person makes these repairs per their recommendation.

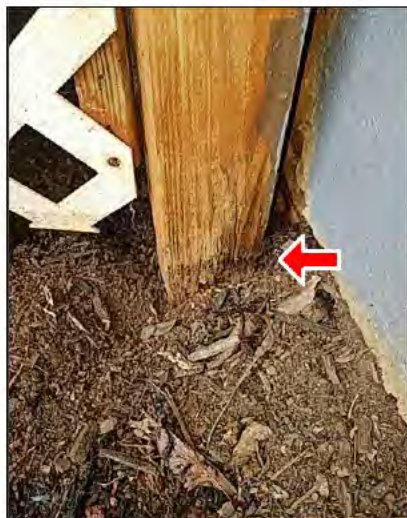
2.3 Item 1(Picture)

The back right corner post of the front deck system has rot and decay at the base. I recommend having this further evaluated by a licensed contractor and repairs made per their recommendation.

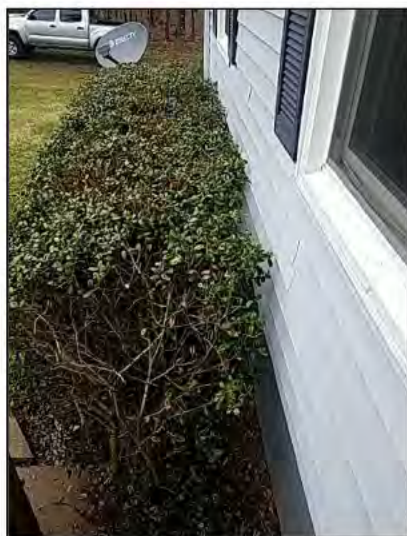
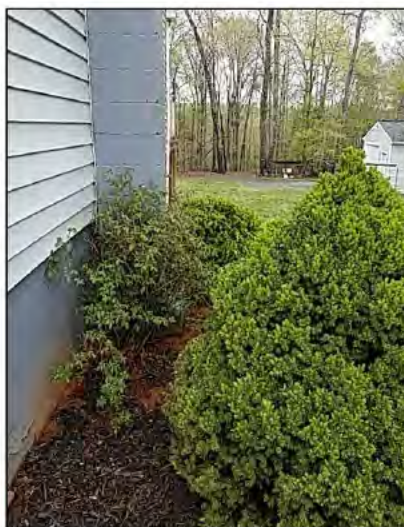
(1) I recommend keeping any and all vegetation around the home cut back at least 12 in to prevent any physical damage to the siding and the home.

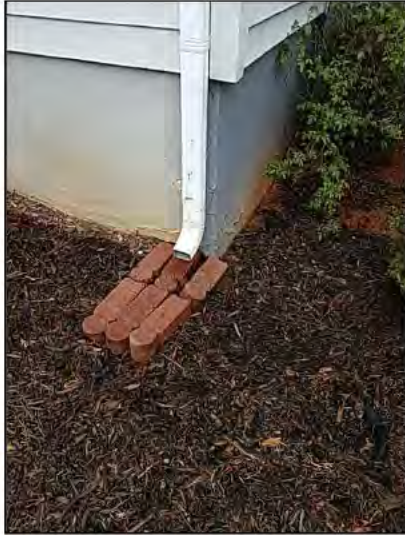
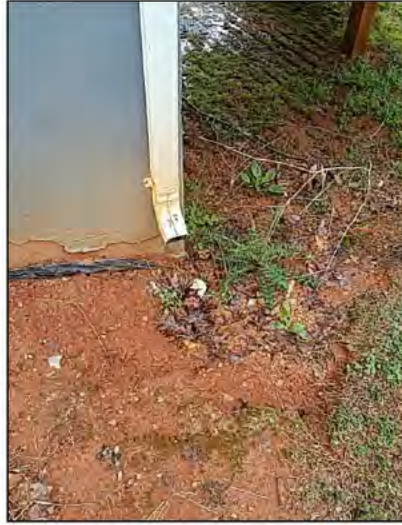
(2) I recommend adding extensions to all downspouts to divert water further away from the foundation walls.

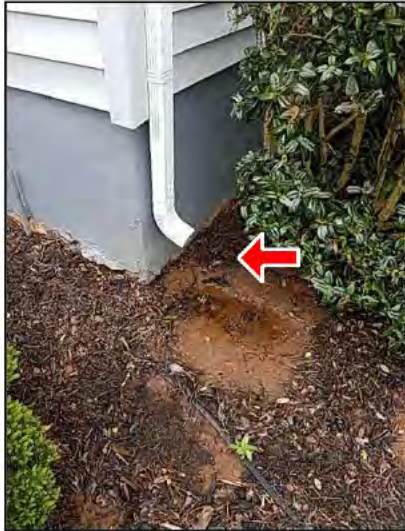
2.4 Item 5(Picture)

(3) The front left downspout is draining too close to the home and water is pooling up at the corner of the home. This could be the cause of the water entering the basement through the foundation wall. I recommend having an extension added to the downspouts to divert water away from the foundation wall.

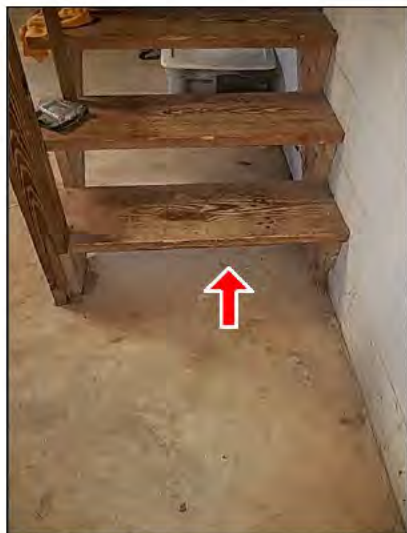
4.3 Item 1(Picture)

The bottom step on the stairs in the basement is too high which this is a trip hazard, I recommend having this repaired.

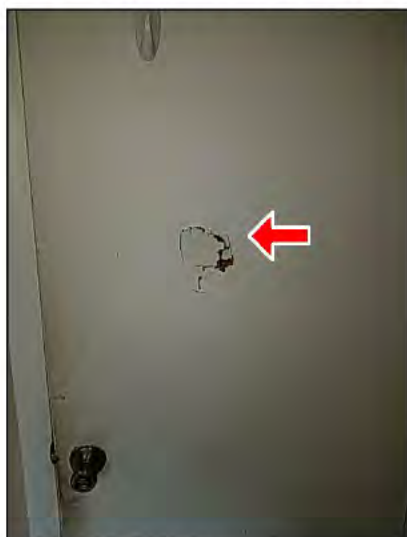
4.5 Item 1(Picture)

(1) The door to the first bedroom on the left is damaged, I recommend having this replaced.

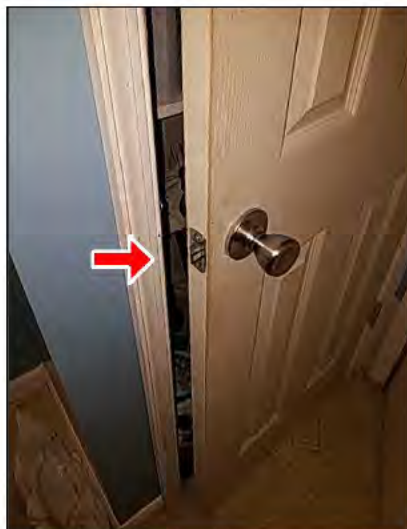
4.5 Item 2(Picture)

(2) The closet door in the bathroom does not properly latch, I recommend having the door adjusted so it closes properly.

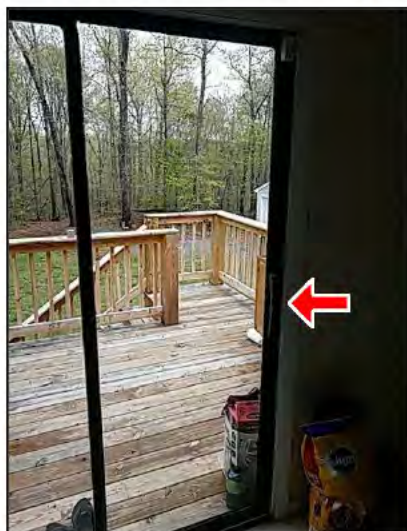
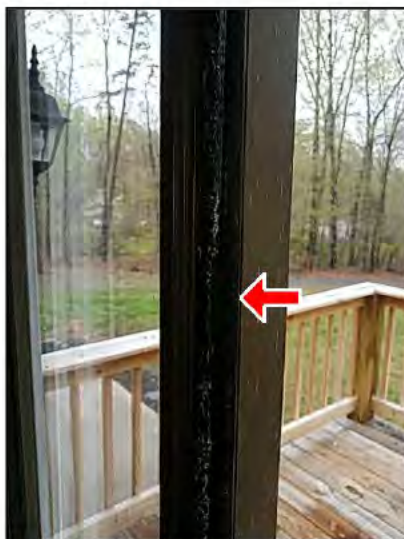
(3) The inner pane of glass for the sliding glass door to the back is broken, and the frame where the door locks are also loose. I recommend having the door replaced.

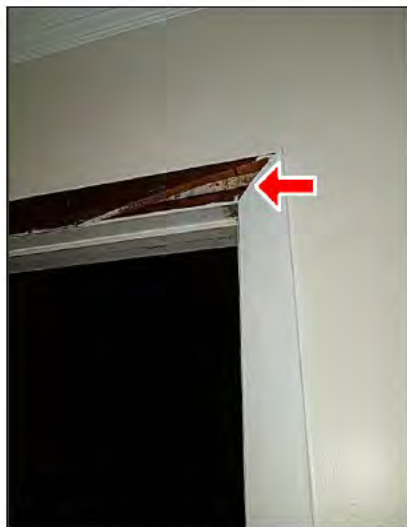
4.5 Item 5(Picture)

(4) There is a damaged piece of trim on the door leading to the basement, I recommend having this replaced.

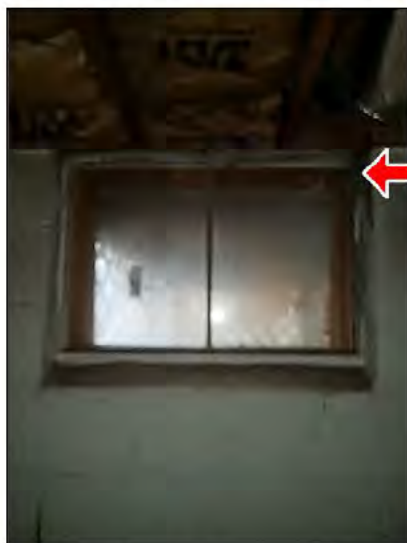
4.6 Item 1(Picture)

Two of the basement windows have daylight visible around them which could allow unwanted pets to enter the home. I recommend having these properly sealed by a qualified person.

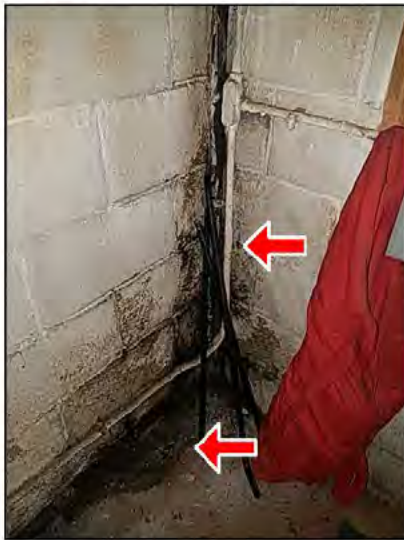
5.0 Item 1(Picture)

The front left corner of the foundation wall in the basement has signs of moisture on the block and the floor. I recommend having a licensed contractor further evaluate and correct the drainage issue on the front left of the home to prevent water from penetrating the foundation wall.

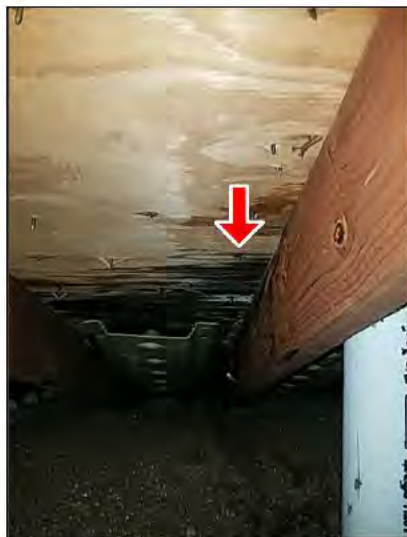
5.5 Item 1(Picture)

The section of sheathing below the plumbing vent stack in the attic has signs of rot and decay as well as visible fungal growth. I recommend having this further evaluated and repaired or replaced by a qualified person's recommendation.

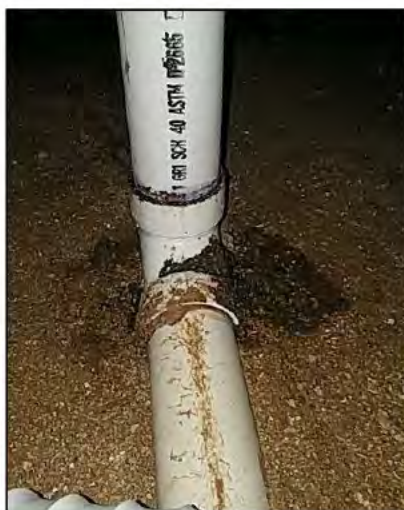
6.0 Item 2(Picture)

(1) There is daylight visible around a plumbing vent stack in the attic which is allowing water to enter the attic space. The insulation around the base of the plumbing stack is wet and there is rot starting on some of the sheathing below the vent stack. I recommend having a qualified roofer further evaluate and make repairs per the recommendation.

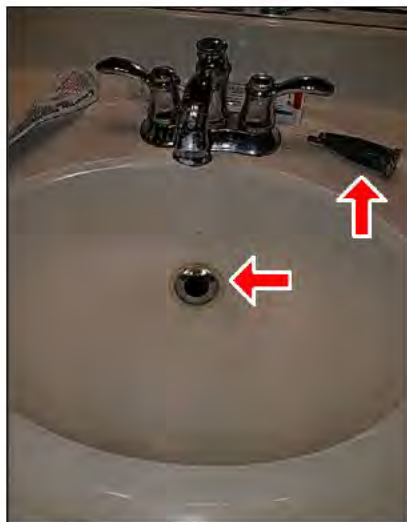
6.0 Item 3(Picture)

(2) The drain stop in the bathroom sink is not connected, I recommend having this installed.

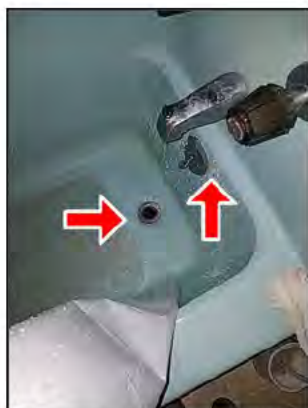
6.0 Item 4(Picture)

(3) The drain stop in the shower/tub is not working properly, I recommend having a qualified plumber make this repair.

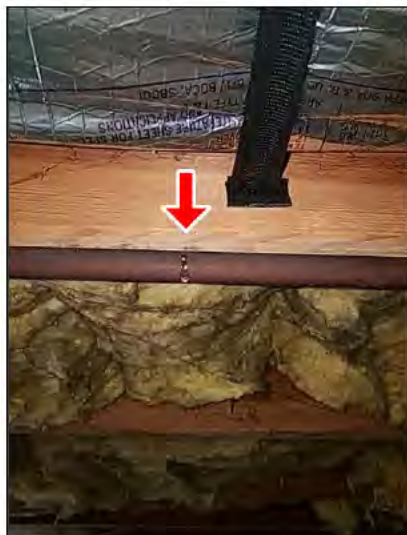
6.1 Item 1(Picture)

In the basement where the PEX meets the copper water line, there is a slow leak. I recommend having a qualified plumber make this repair.

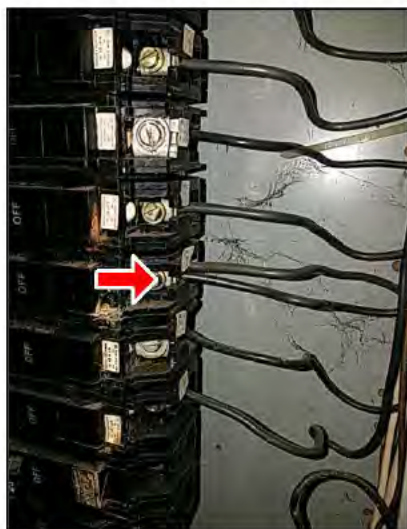
7.2 Item 1(Picture)

There is a double tap on a 20 amp breaker on the right side in the panel which is a fire hazard. I recommend having a qualified electrician make this repair.
