## Inspection Report

Palmyra VA 22963

**Jensen Home Inspections LLC.**

<b>Date:</b> 4/25/2018	<b>Time:</b> 01:00 PM	<b>Report ID:</b> 4/25/18
<b>Property:</b> [REDACTED] Palmyra VA 22963	<b>Customer:</b> [REDACTED]	<b>Real Estate Professional:</b> Amanda Spigone Keller Williams Realty

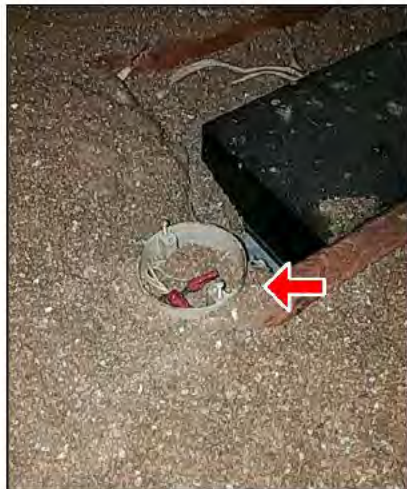
7.3 Item 1(Picture)

(1) There is an open junction box in the attic space, I recommend having a cover installed.

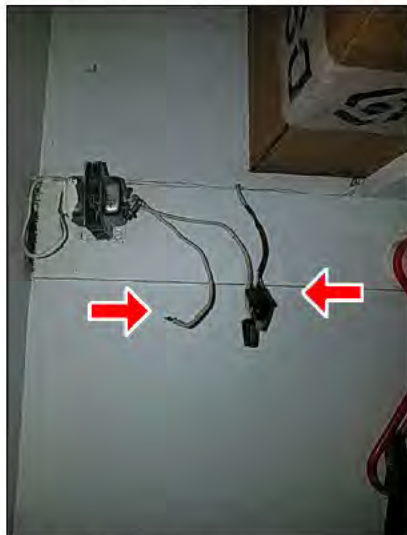
7.3 Item 2(Picture)

(2) There are exposed wires in the closet in the first bedroom on the left. I recommend having an electrician properly run the wires in the junction box.

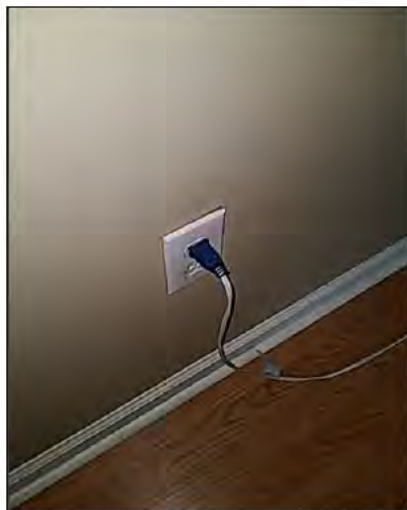
7.3 Item 3(Picture)

(3) There are several receptacles in the home that are loose in the walls. I recommend having a qualified electrician properly secure any loose receptacles.

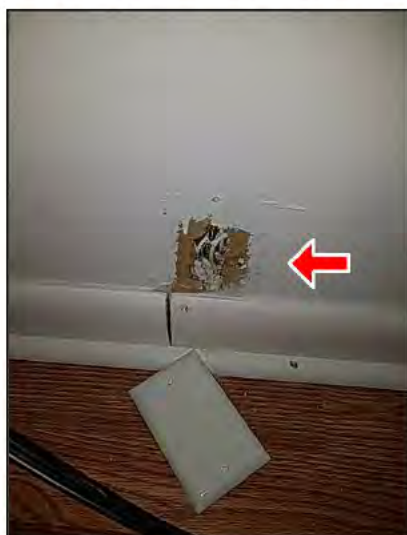
7.3 Item 4(Picture)

(4) In the first bedroom on the right, there is a blank plate mounted to the wall. As I walked by it the cover fell off the wall, and there is a hole with exposed wires tucked into the wall. I recommend having these wires properly run through a junction box and a cover properly installed by a qualified electrician.

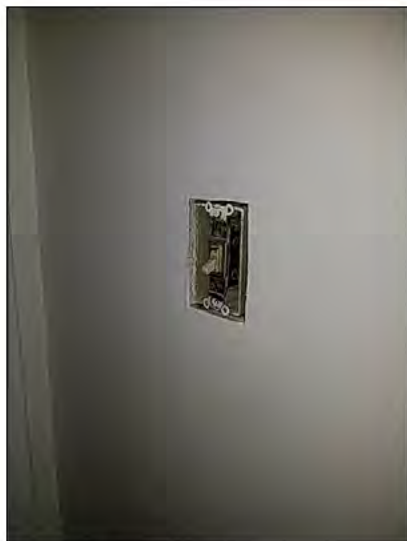
7.3 Item 5(Picture)

(5) The light switch cover in the first bedroom on the right is missing, I recommend having one installed.

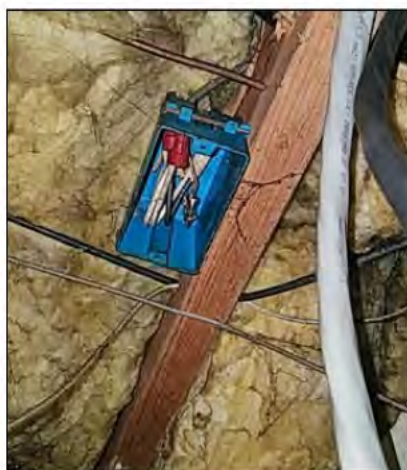
7.3 Item 6(Picture)

(6) There is an open junction box that needs a cover just above the electrical panel in the basement.

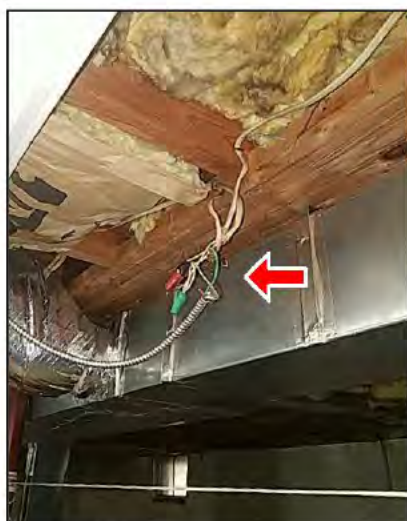
7.3 Item 7(Picture)

(7) The wiring on one of the overhead lights in the basement is exposed. These wires should be run in a junction box, I recommend having a qualified electrician make these repairs.

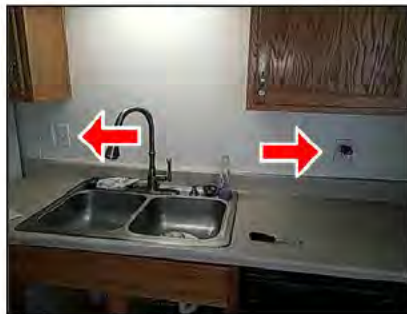
7.5 Item 1(Picture)

The receptacles in the kitchen that are all within 6 feet of the sink are not connected to a GFCI receptacle or GFCI breaker. I recommend having a qualified electrician make this repair.

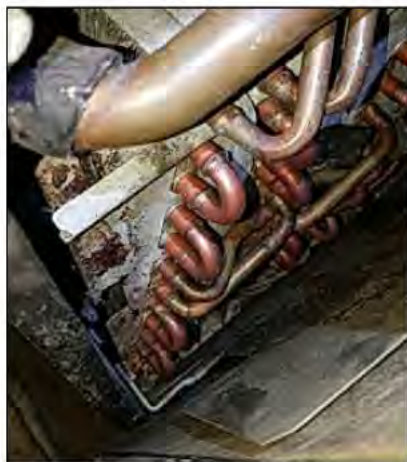
8.3 Item 1(Picture)

They are early signs of rust around the coil in the air handler as well as some microbial growth. I recommend having a licensed HVAC technician clean, service, and further evaluate the unit.

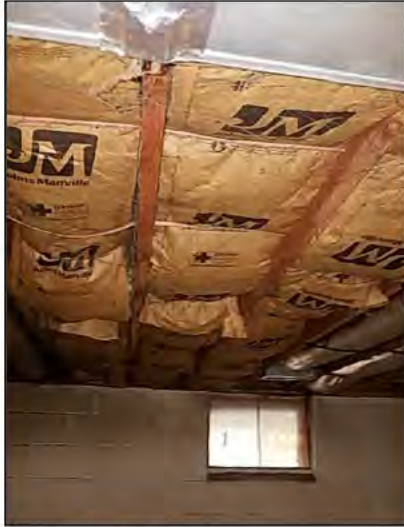
9.1 Item 1(Picture)

Most of the flooring insulation in the basement is installed upside down, and the paper vapor barrier is supposed to be against the flooring. I recommend having this corrected or the insulation replaced.

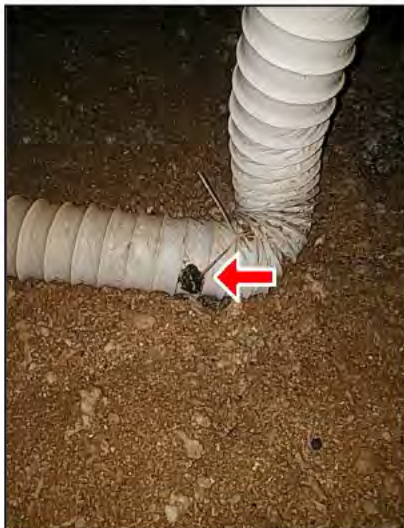
9.4 Item 1(Picture)

In the attic space, the bathroom vent has a mouse hole in the side and it does not vent to the exterior of the home. I recommend having this replaced and properly vented to the exterior of the home.

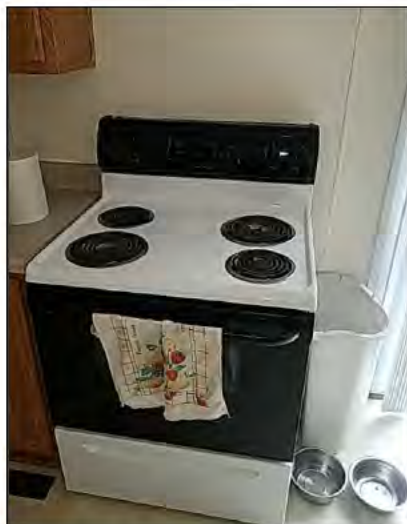
10.1 Item 1(Picture)

The range is missing its anti-tip plate, I recommend having one installed.
